THE CALIFORNIA EARTHQUAKE OF APRIL 18, 1906

STATE EARTHQUAKE INVESTIGATION COMMISSION

IN TWO VOLUMES AND ATLAS

ANDREW C. LAWSON, CHAIRMAN

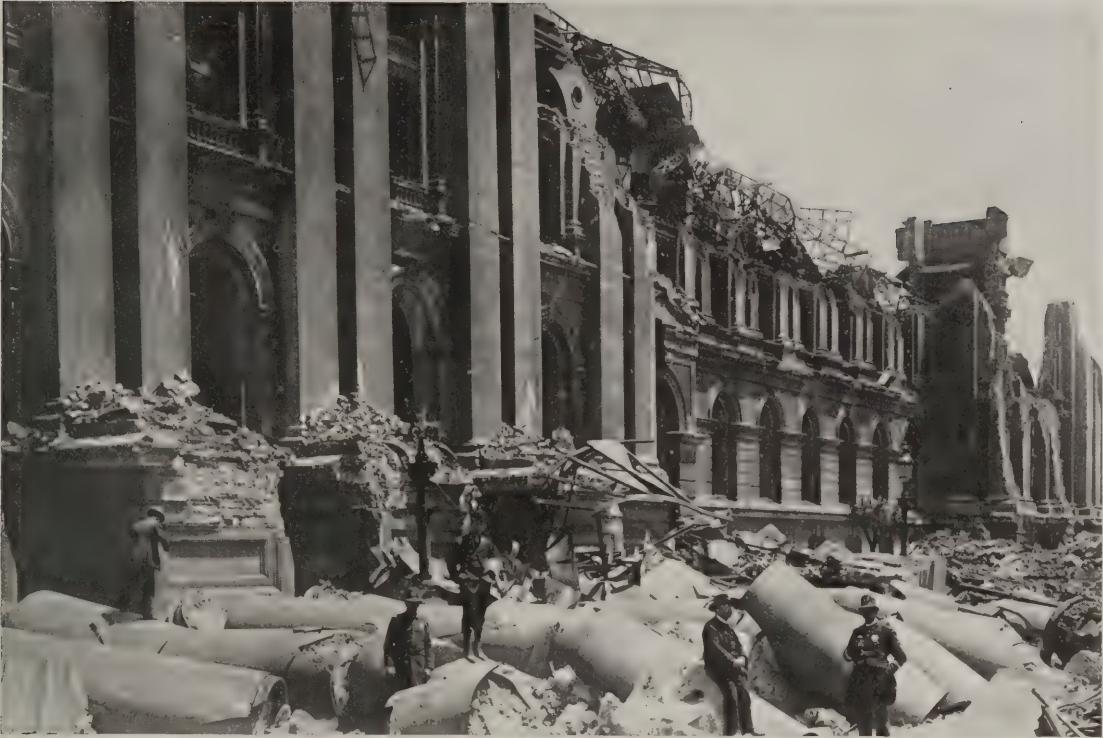
A. A near view of the wreck at the City Hall, San Francisco.

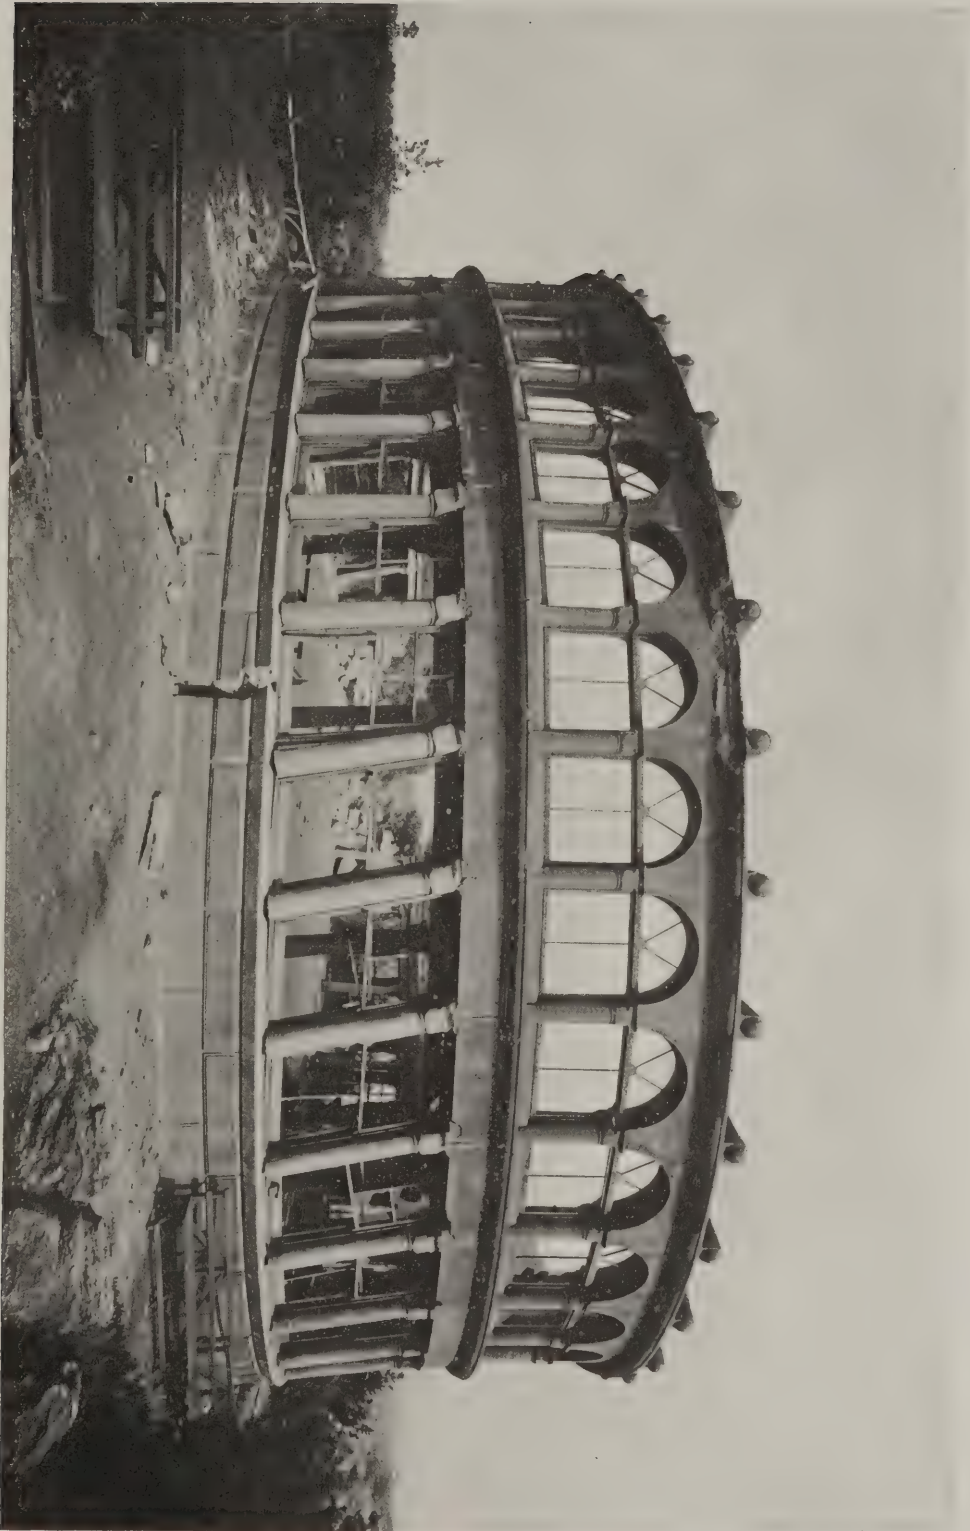
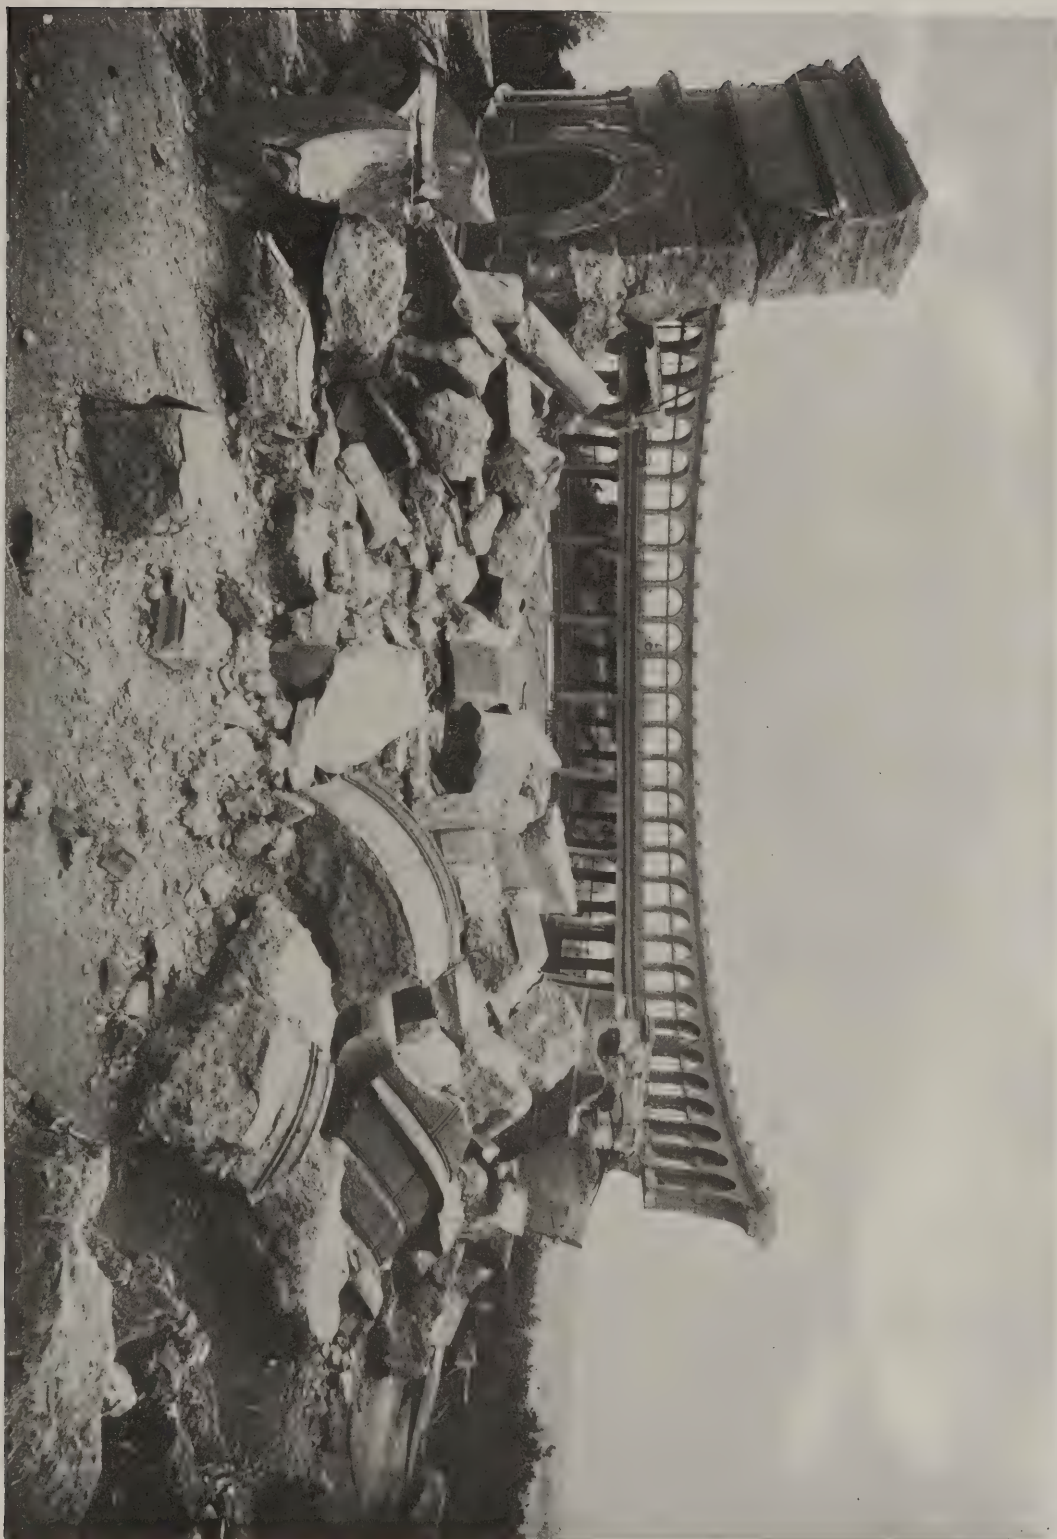
Observatory, Strawberry Hill, Golden Gate Park, San Francisco. W. E. Worden, Photo.

Strawberry Hill, in Golden Gate Park, is a chert knob rising abruptly in the sand wastes. Its summit had been leveled, but it is not known whether this was done by cutting off the top and filling out the upper slopes, or by filling alone. The altitude given for the present hill is the same as that given in the earliest accurate surveys. Much artificial stone work, and a circular concrete observatory building 2 stories high, had been erected upon the leveled hilltop. This building was of weak design, having a row of columns, with windows between, which rested upon a foundation wall 3 feet high and supported a heavy second-story balcony. The construction itself was probably good, but the observatory was utterly ruined by the shock. (Plates 84 and 85.) The entire lower story was sheared out of position, and part of the balcony fell. The cement floor showed numerous cracks arranged in a roughly concentric way.

The whole periphery of the hilltop was broken into a series of concentric blocks or steps, and the outer ones moved down the hill from 2 to 3 feet. The artificial stone work was badly cracked and dislodged. These phenomena indicated that the material used in grading the upper slopes had settled somewhat, with consequent rupture of the surface and wrecking of the building. No other explanation can be urged for such striking damage on this hill, in view of the small damage produced on other rock summits in the city.

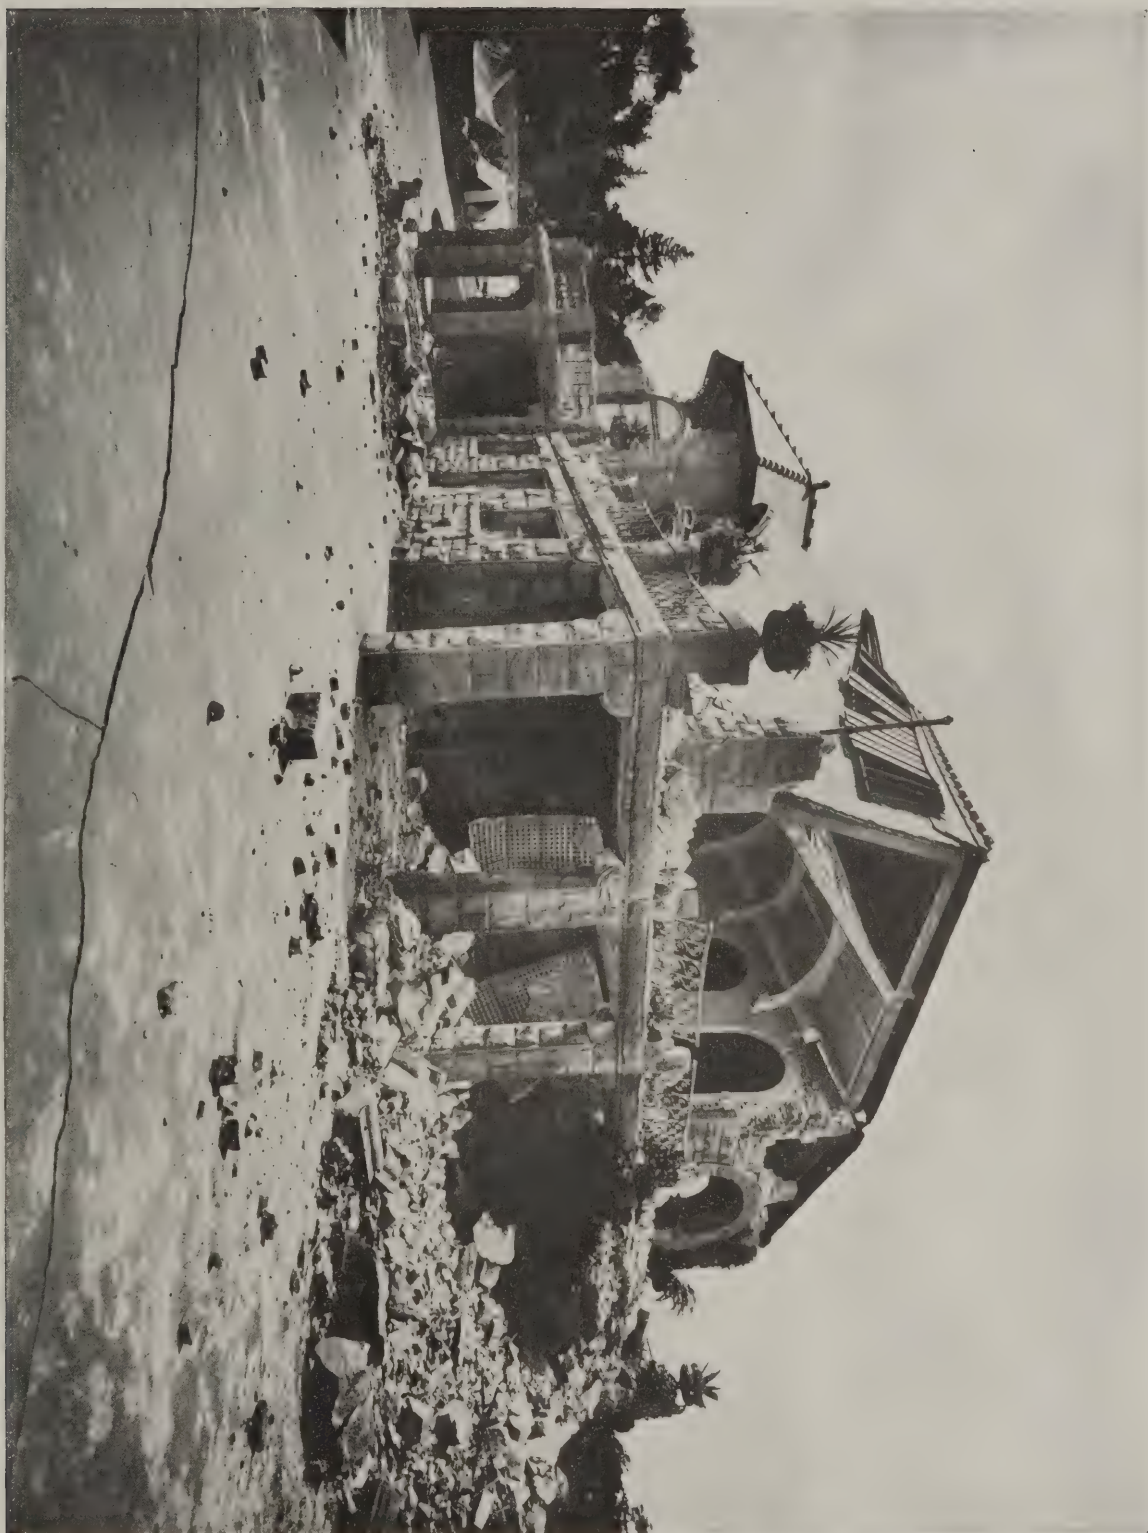
The Park Emergency Hospital, near the southeast corner of Golden Gate Park, had its walls badly cracked and its gable thrown out. It is a small, 1-story, sandstone building, with a wooden frame. Its site was loose sand of unknown depth, probably extensively graded. Evidently it was not an excellently built structure. The restaurant at the children's playground in the Park was wrecked. (Plate 86.)

Restaurant at Children's Playground, Golden Gate Park, San Francisco. W. E. Worden, Photo.

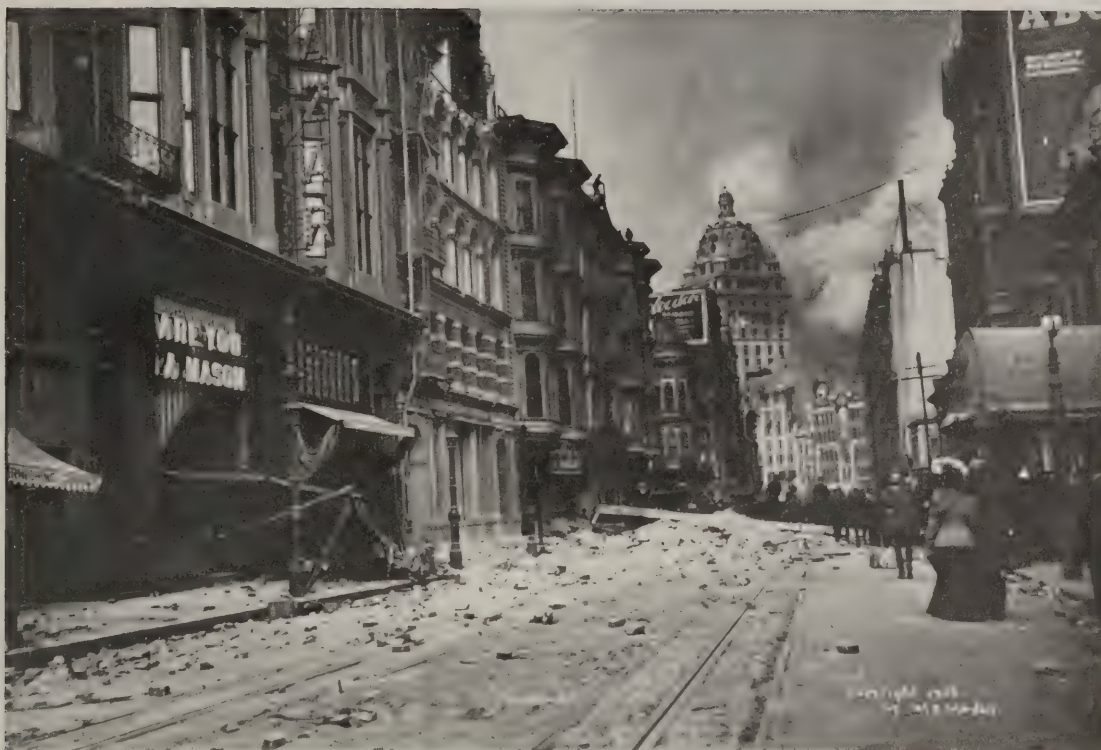
A. O'Farrell Street, San Francisco, after earthquake and before fire.

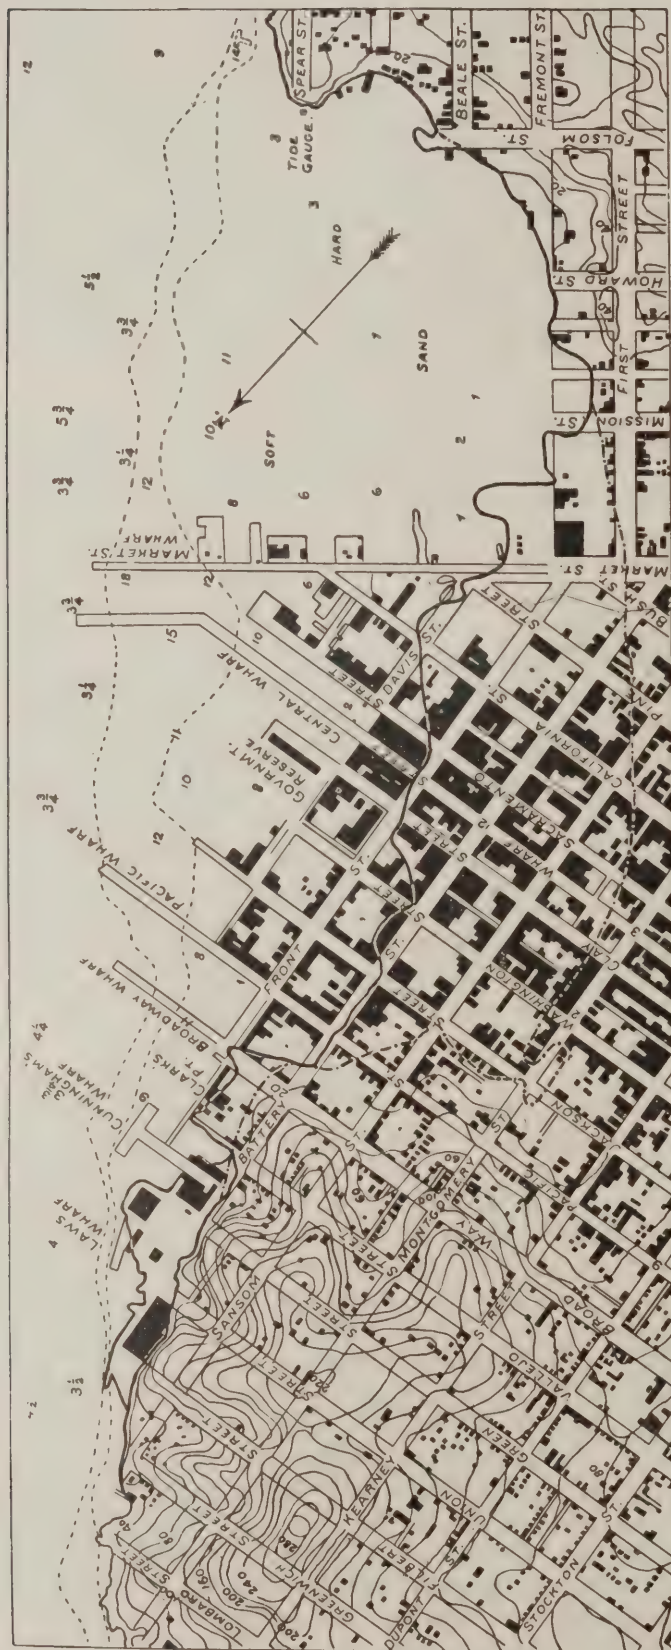
FIG. 51.— Map showing original high-water line of Eddy survey (dot and bar) and mean low-water line or "zero contour" (full line) for district about foot of Market Street in 1833. From Chart of Coast and Geodetic Survey.

It is of interest to inquire whether all or only a portion of this district in which high intensity was developed is "made" land. In the map (fig. 51) is reproduced a portion of the U. S. C. & G. S. chart, "City of San Francisco and its Vicinity," published in 1853 from surveys made in 1851-1852. On it the dot-and-bar line represents the course of the "original high-water line according to plot of Wm. M. Eddy's survey dated 1852." The "zero contour" which determines the configuration of the shore, except where wharves put out, is shown by a continuous line; it is not expressly defined, but it is believed to represent mean low-water, as the soundings are measured from this level. It is needless to point out that this contour is drawn farther seaward than the original high-water line. The portion thus delimited has an area of not less than 20 city blocks, partly or wholly occupied by buildings. Quite outside the "zero contour," as shown on this map, are 8 complete blocks and portions of others — an area of not less than 10 city blocks, partly or wholly built upon. If, then, confidence may be placed in the location of the original high-water line of the Eddy survey of 1852, there were already in San Francisco 30 blocks of "made" land, occupied wholly or in part by buildings before the end of 1853, less than 4 years after the sudden rush to California which followed the discovery of gold in 1849. The revised chart of 1857 shows that very little additional land was made in this district in the succeeding four years.

Without conflicting evidence from other surveys, and no such evidence has been found, the high-water line established by the Eddy survey can not be discredited. Still it is proper to state that these facts raise some doubts as to the accuracy of its delineation, and that the evidence developed by the earthquake does not tend to dispel these doubts. The gradation in the effects produced by the shock, from great magnitude at the waterfront to small at the former land margin, would suggest that at least the marginal district where only Grade C intensity was developed, tho outside the location of the original high-water line, might not be made land, altho it has undoubtedly been somewhat elevated by grading. Very little stress can be laid on this suggestion, however, for these districts suffered very severely in the earthquake shock of 1868; but the materials used in filling were then, of course, shaken together, and in addition, the slow settling together from year to year has undoubtedly compacted the earlier made land much more than that recently "made." Besides, the exhibition of damage depends upon the character of the structures in a given locality, as well as upon the ground, and it is to be noted that the buildings along Kearney, Montgomery, and Sansome Streets comprized a larger percentage of excellent structures than the streets nearer the wharves. The problem is thus complex, and very likely unsolvable; but there remains the haunting suggestion that the "original high-water line" does not constitute the landward boundary of the "made" land, properly speaking. At any rate, it is very clear that that which was known to be "made" land suffered much more severely than that which was known to be natural alluvium.

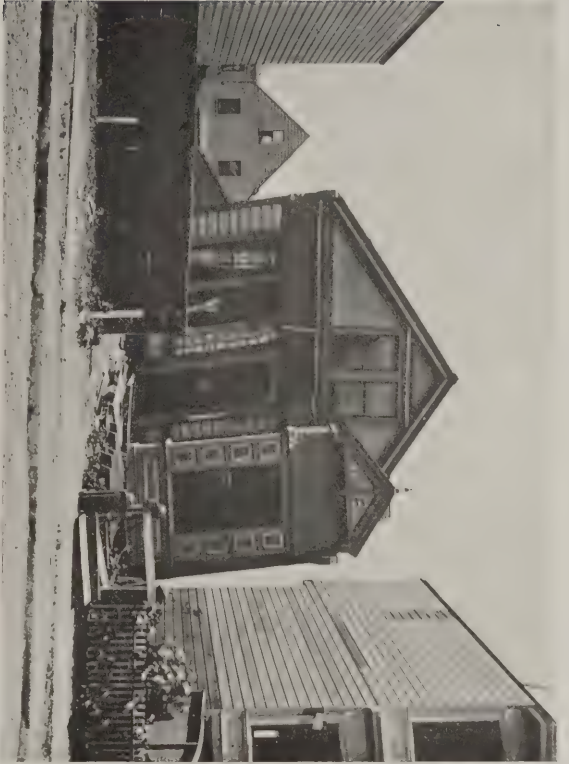
A. Frame building on west side of Eleventh Avenue, just south of California Street, San Francisco. A weak structure, built on sand. H. O. W.

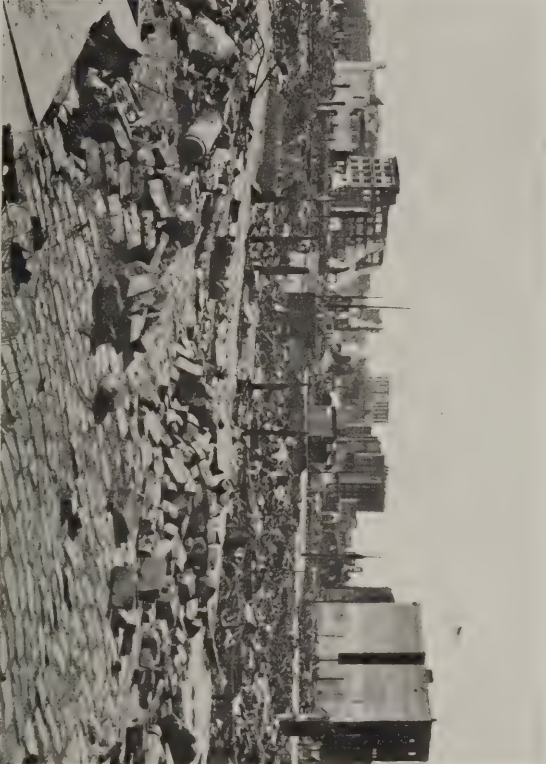
C. Russ Street, between Polson and Howard Streets, San Francisco. Paving blocks forced up into sharp arches and dislodged by compression. H. O. W.

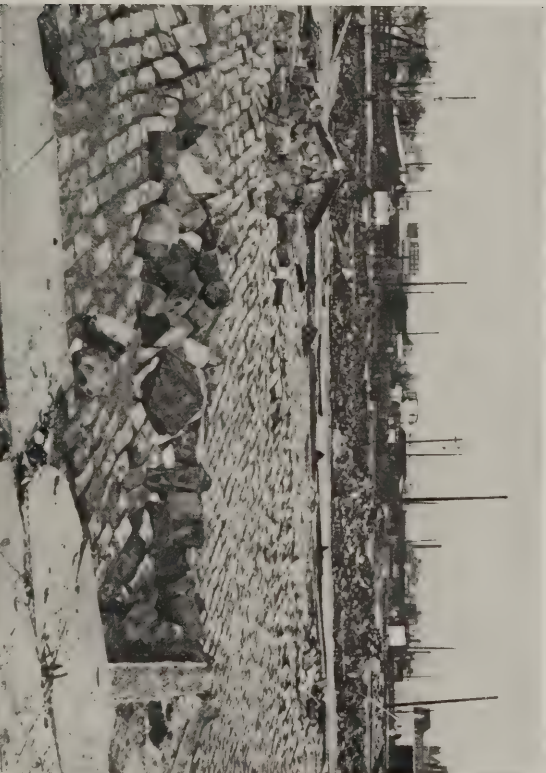
D. Moss Street, between Polson and Howard Streets, San Francisco. Paving blocks arched by compression along sinuous crest, curbing thrown into an inverted V. H. O. W.

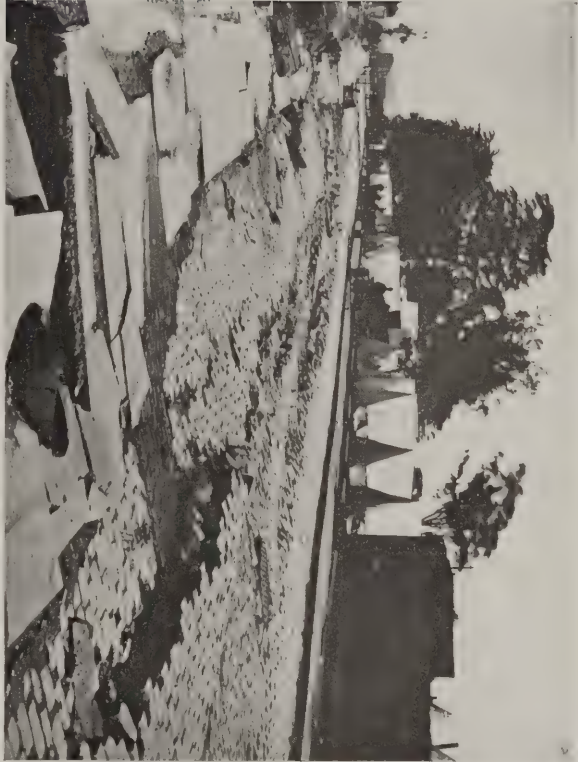
A. Columbia Street, just south of Polson Street, San Francisco. Slumping, depression, and furrowing of block pavement. H. O. W.

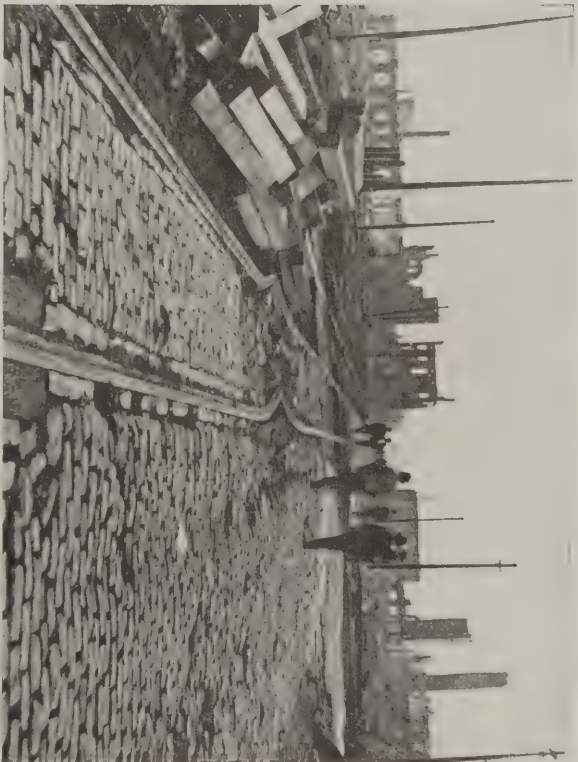
B. Bryant Street, near Fourth Street, San Francisco. Flexure of heavily ballasted car tracks in block pavement ; an effect of sharp compression. H. O. W.

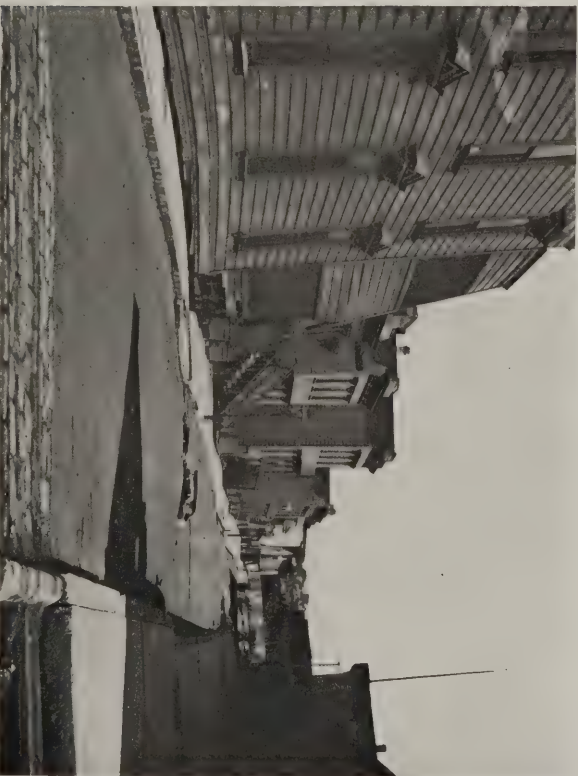
D. Looking along Dore Street, from Bryant toward Brannan. Undulating and fractured condition of pavement due to earthquake. Houses thrown off their underpinning and pitched out of the vertical. H. O. W.

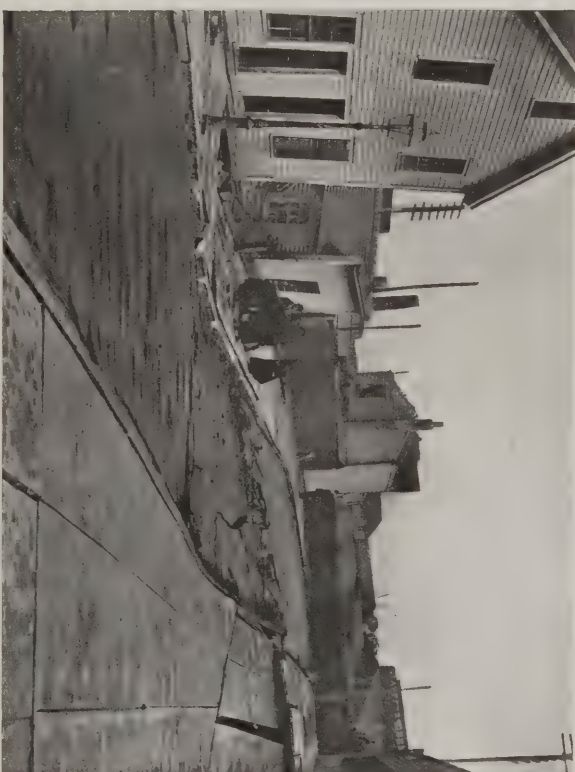
B. Dore Street, near Brannan. Vertical difference between crest and trough of undulations, 5 feet. H. O. W.

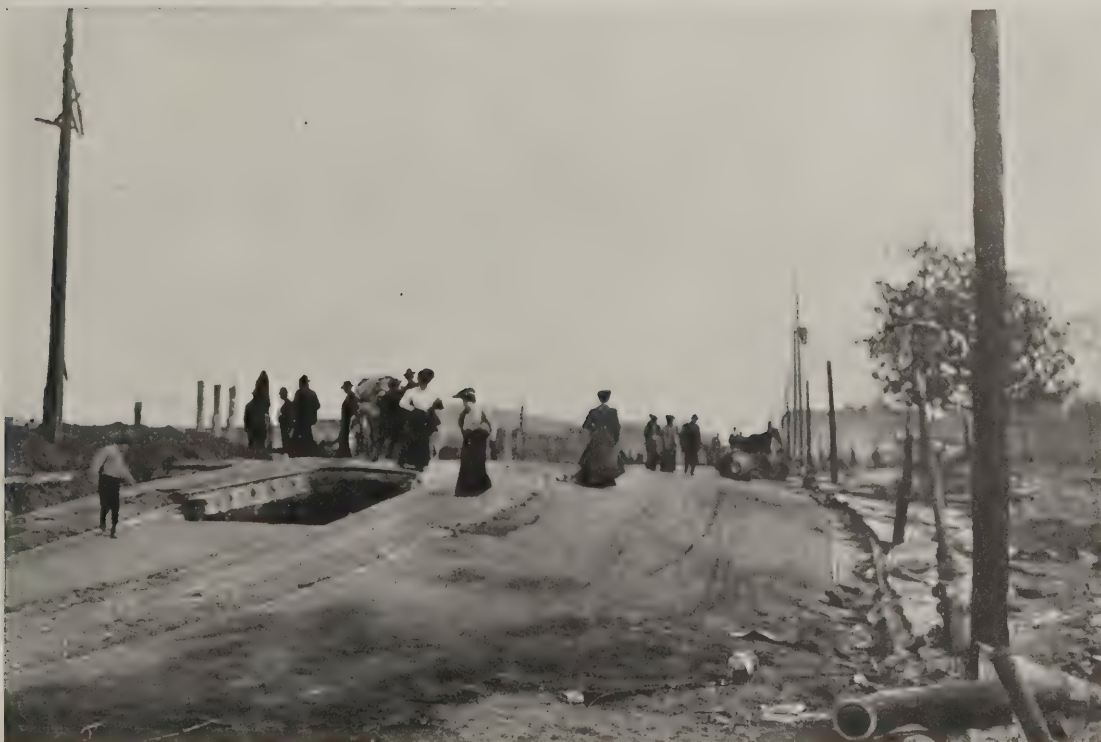
B. Valencia Street, near Eighteenth. Land in this neighborhood sank about 6 feet, flexing street surface. A. C. L.

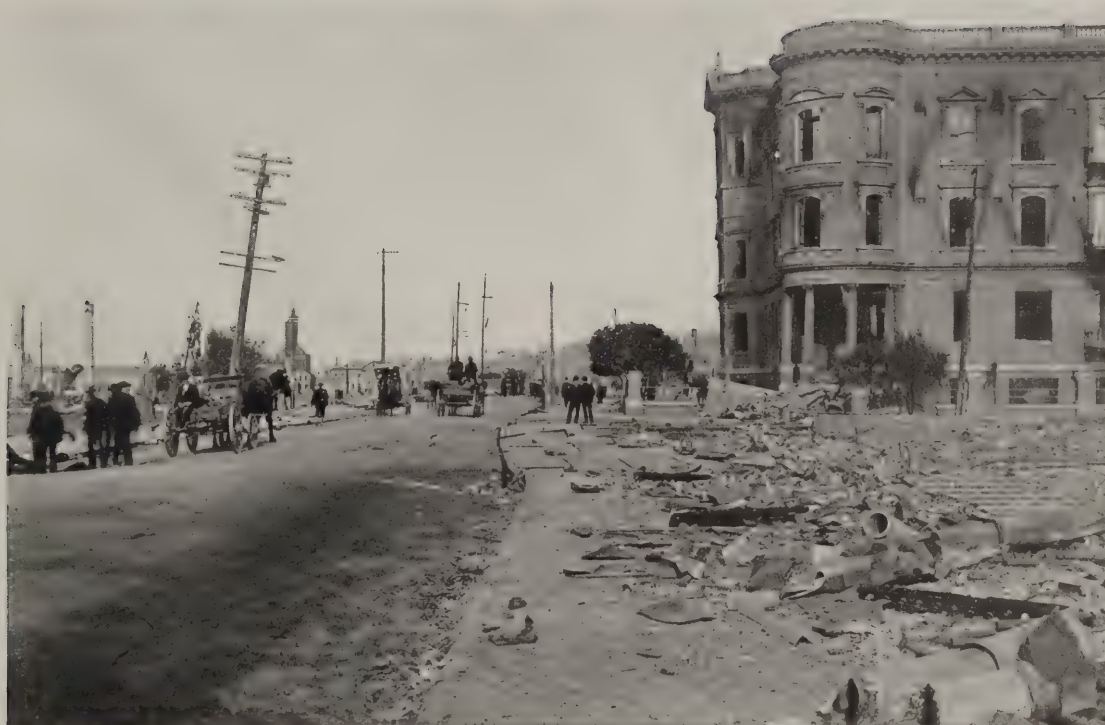
A. View along Nineteenth Street, from Guerrero Street. Both ground and buildings moved north about 6 feet toward center of old marsh, with component of movement down the channel. A. C. L.

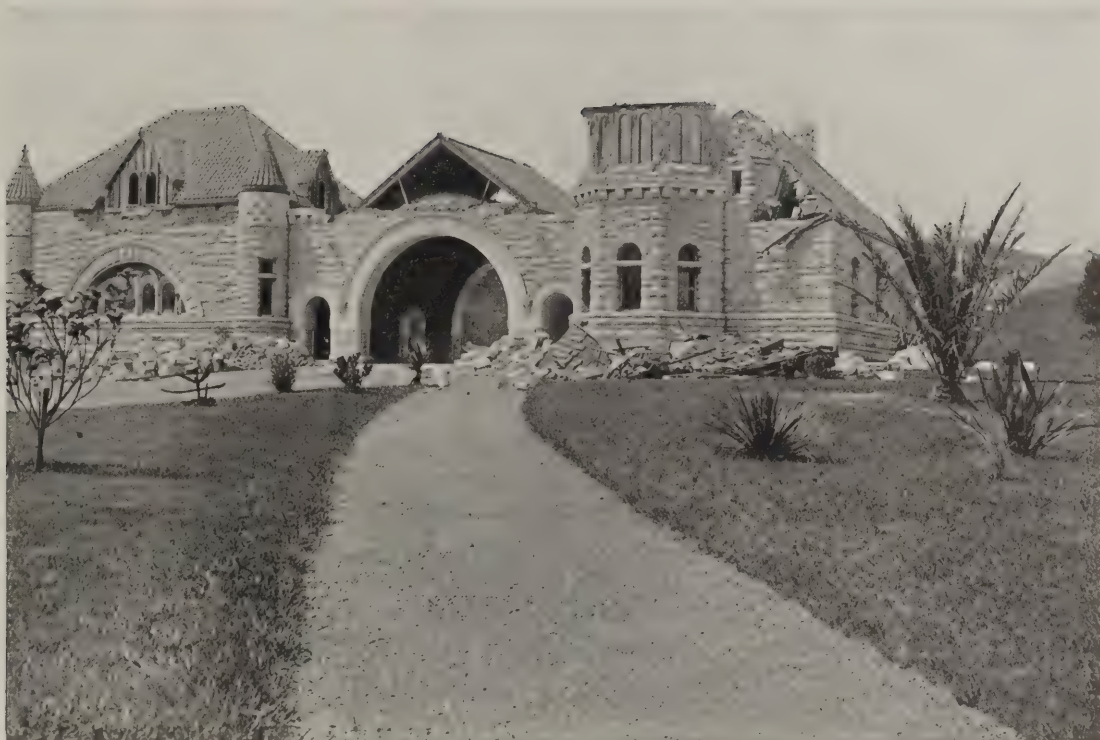
A. Woodlawn Cemetery, south of San Francisco. A. C. L.

There was a large amount of damage done in the cemeteries, which are on æolian sands.

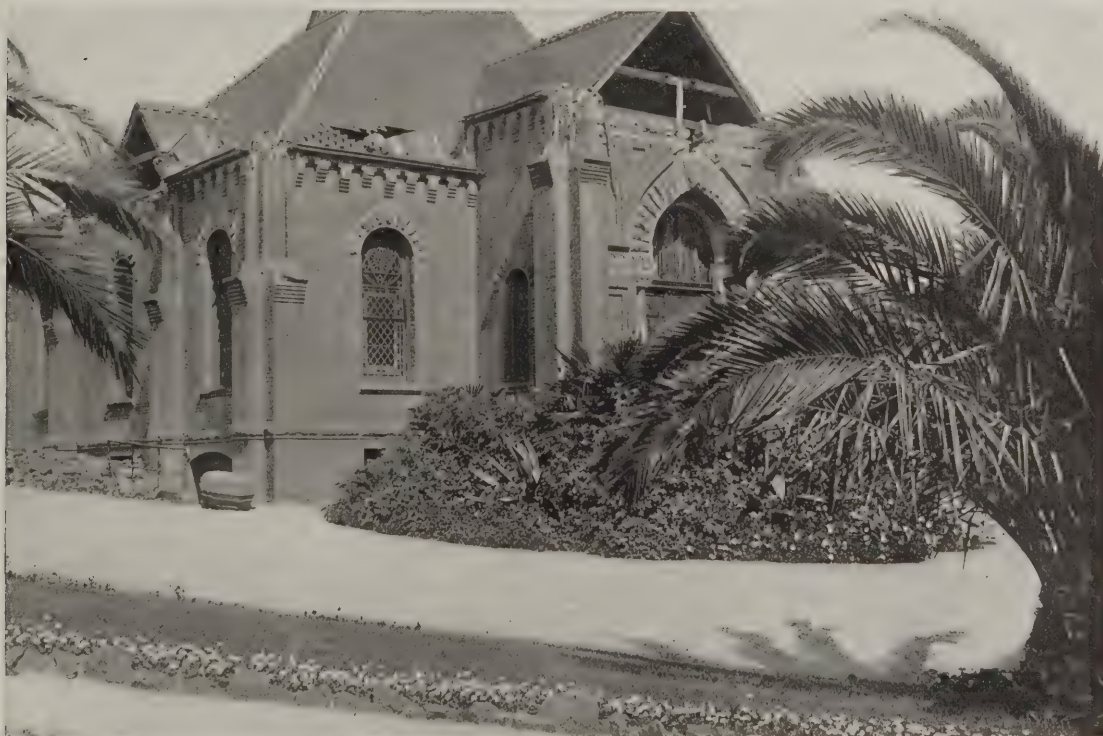
B. Hills of Eternity Cemetery, south of San Francisco. All four gables thrown out. Parapets thrown in on roof. A. C. L.

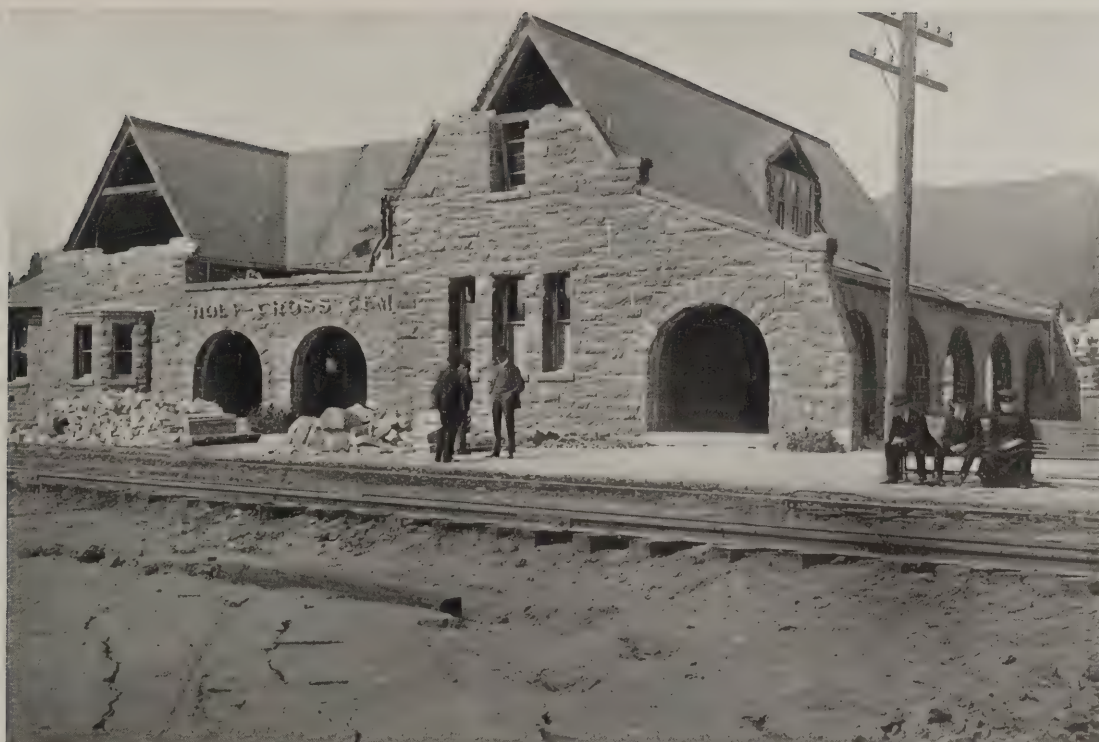
A. Holy Cross Cemetery Station, south of San Francisco. Building on made ground. A. C. L.

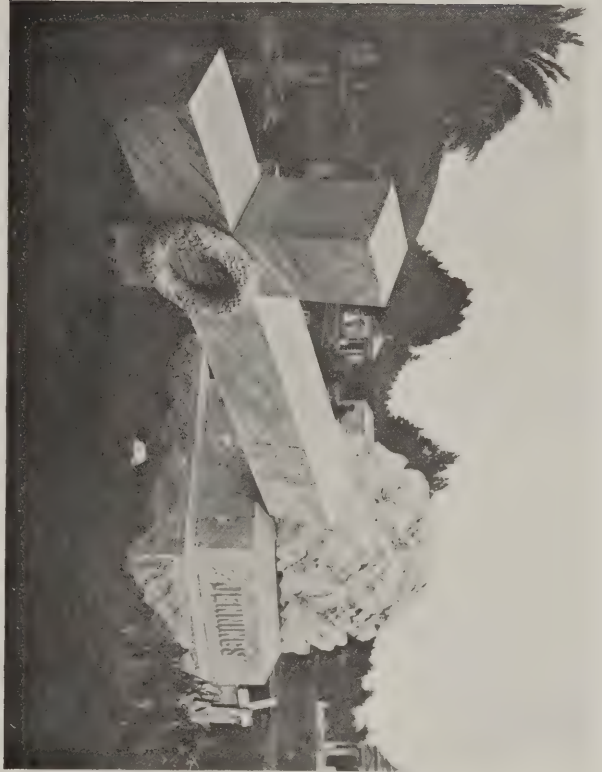
A. Overthrown monument, Holy Cross Cemetery. R. B. M.

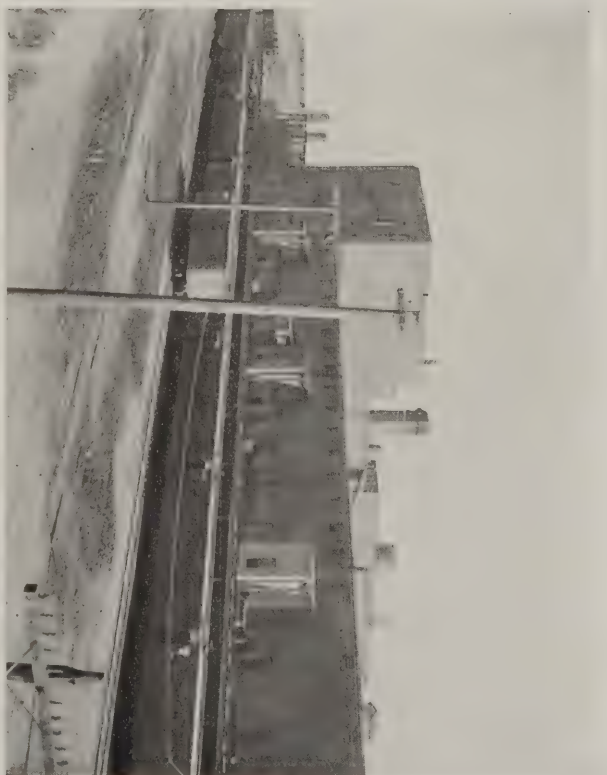
B. Brick building and high chimney left standing. South San Francisco. R. B. M.

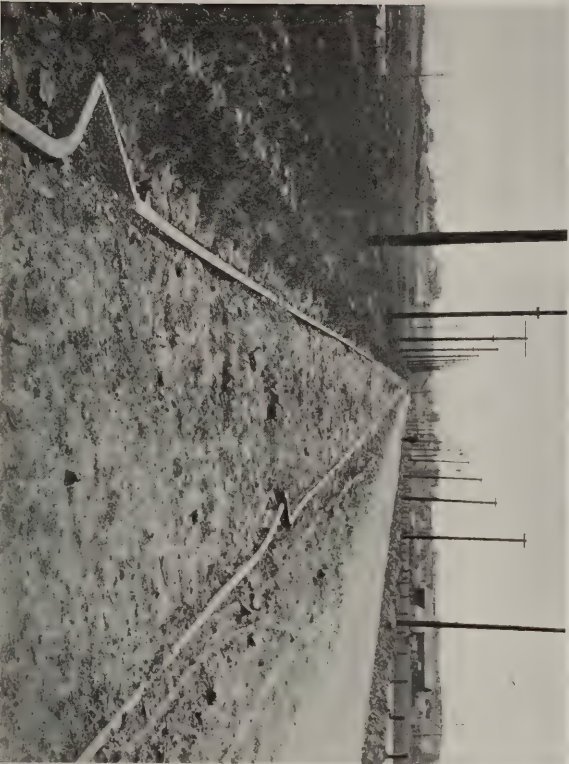
C. Roadbed and rails of electric railway on marsh west of San Bruno. R. B. M.

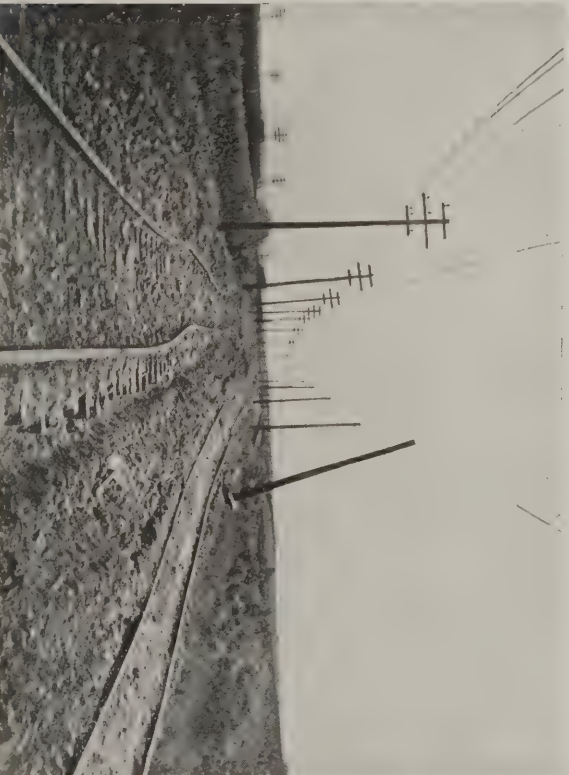
D. Roadbed and rails of electric railway between Baden and San Bruno. R. B. M.

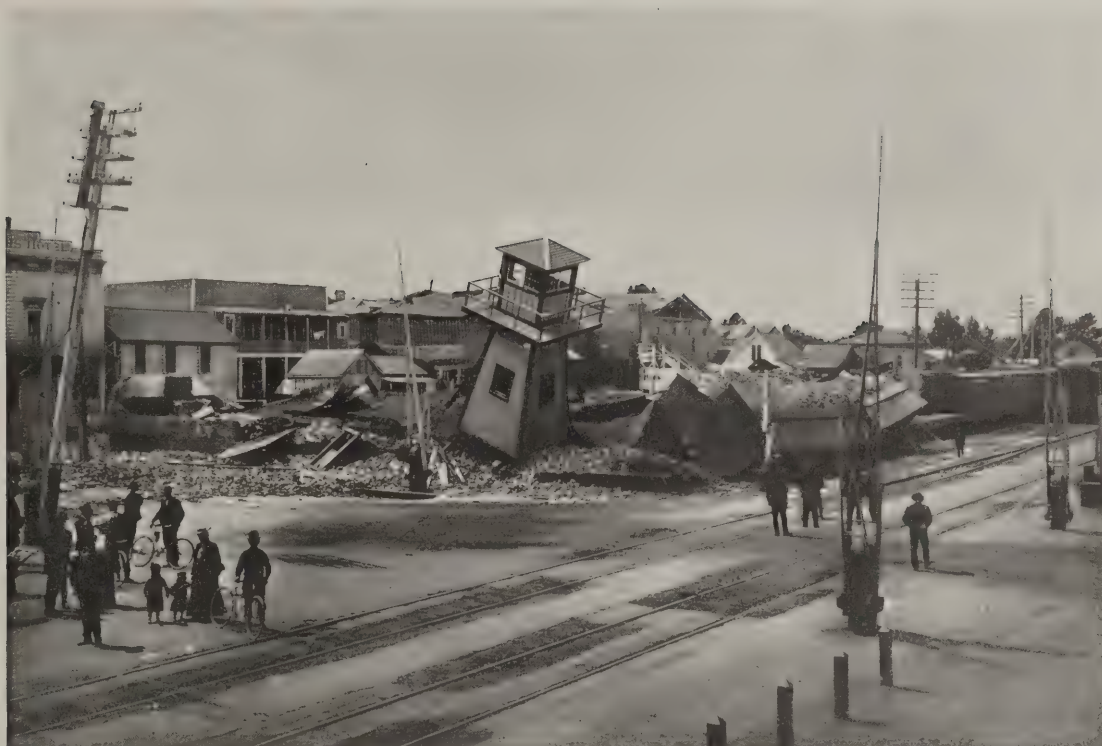
A. Wreck of 1-story brick railway warehouse, San Mateo. Per J. C. B.
